# BUILDING SCIENCE **perspective**

## **AUPE HEADQUARTERS FEATURES 3D DESIGN CENTERED ON HEALTH & WELLNESS**

The adoption of the unvented wood roof in Alberta

Part 2 of restoring the grand old façade on the Alberta Legislature building to its original glory!

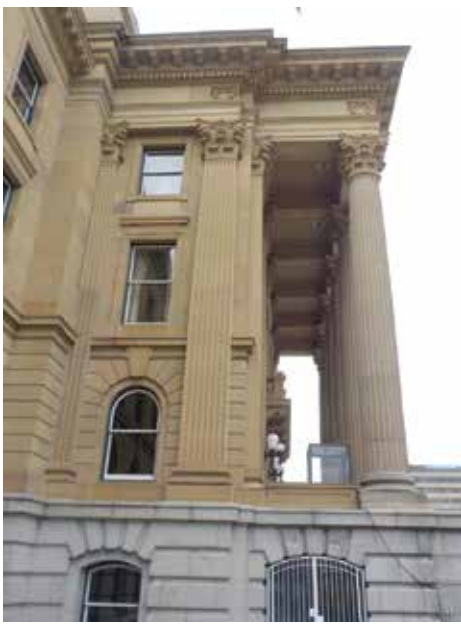
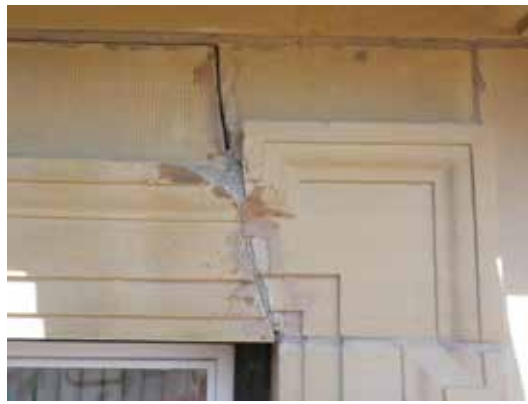
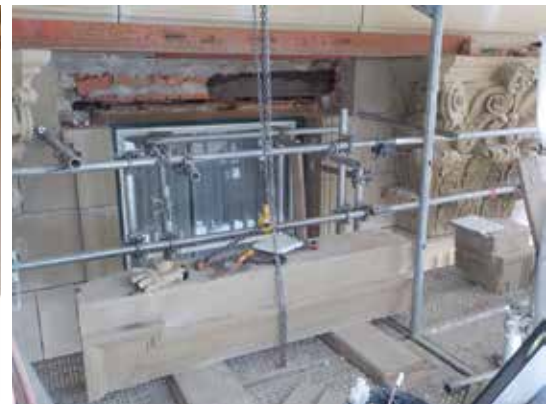
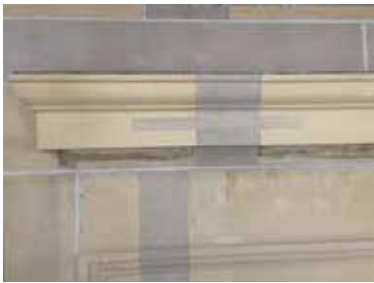
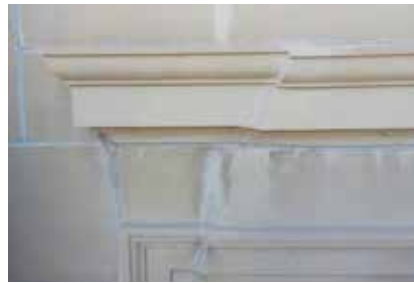
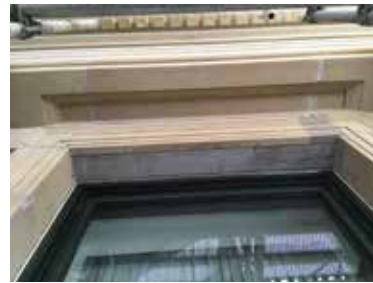
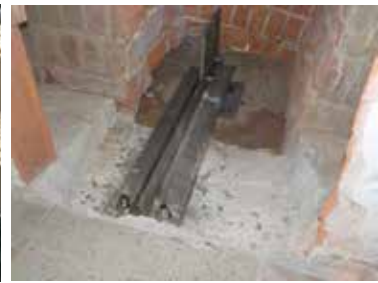
Major vertically oriented cracking

and stone displacement had occurred within the north portico east and west elevation sandstone cladding most likely as the result of differential foundation movements arising from the construction of the 97th Avenue underpass and adjoining underground parkades to the north of the building.

*Clockwise from top left: East elevation of north portico. Cracking and displacement over the east elevation fourth-floor window. Removal of east elevation fourth-floor window head stone to review as-built construction. Tie-back for displaced west elevation infill lower architrave unit. Repair of east elevation fourth-floor window head stone using stitching, Dutchman, and stainless-steel embedded tee. Cracking and movement at west elevation third-floor window head. Repair of west elevation third-floor window head using stitching, embedded stainless-steel tee, and Dutchman repairs.*

Sandstone remediation included removal, repair (complete with stainless-steel dowel stitching and embedment of stainless-steel tees in the bottom of the stones) and reinstallation of cracked third and fourth floor window head stones, repositioning and stitching second and third floor ashlar, sill, frieze and window entablature stones, tying back outward displaced lower architrave

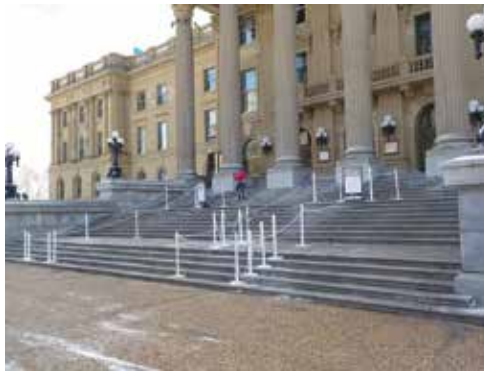
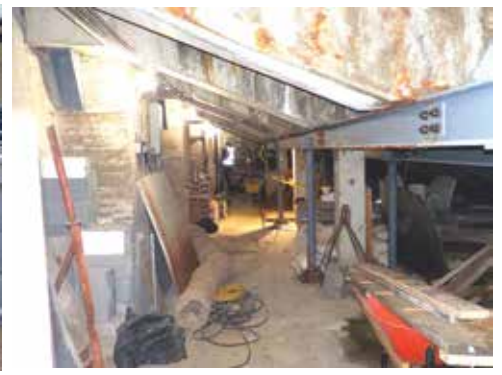
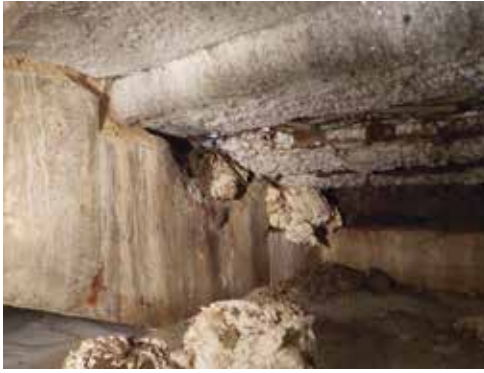
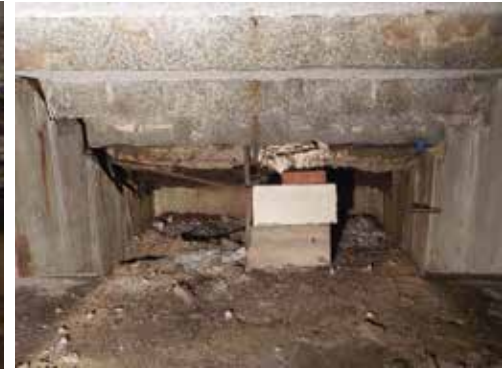
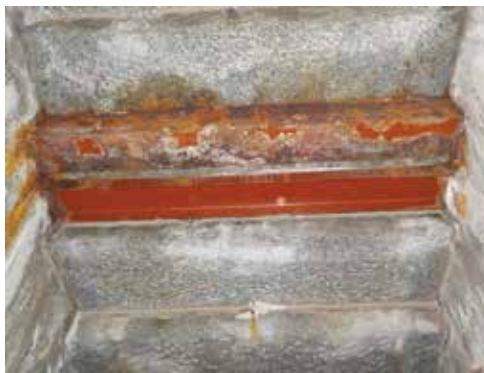
*Clockwise from top left: North stair prior to restoration. 1977 precast concrete raker beam structure and circa 2011 retrofit steel shoring. Deteriorated precast raker beam, tread bedding mortar, and concrete plaza slab at north end of stair. Retrofit channels installed beneath broken granite treads.*

The work of the north stair restoration project included removal of the existing raker beam and retrofit steel support structures, construction of a new full-support cast-in-place concrete stair structure complete with two-ply bituminous membrane waterproofing, and reinstallation of the granite tread and landing stones complete with stainless-steel dowels into the concrete stair structure to affix the granite stones in place.

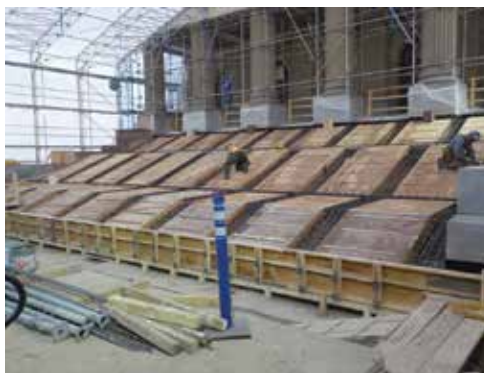
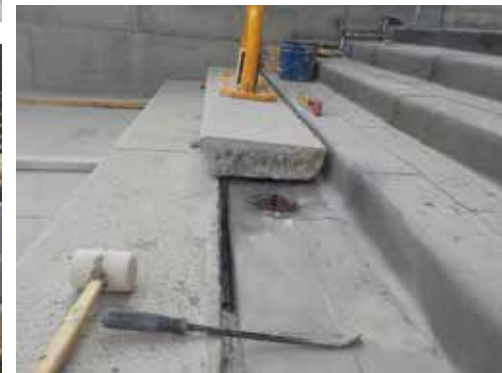
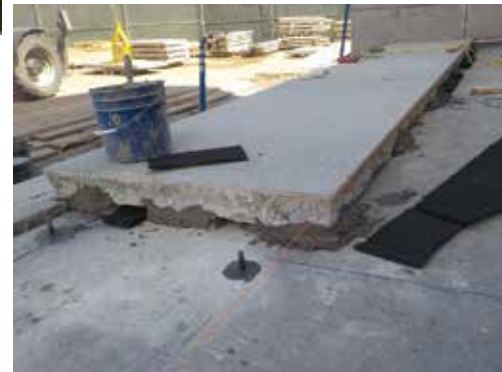
*Clockwise from above: Forming and reinforcing steel for new c.i.p. concrete stair structure. Two-ply waterproofing membrane on top of concrete stair structure. Granite landing stones laid on grout pads complete with stainless-steel dowels.*

The new concrete stair structure incorporated raker beams to reduce the required thickness of the infill slab and minimize the overall weight of the new stair structure assembly so as not to overload the existing foundations.

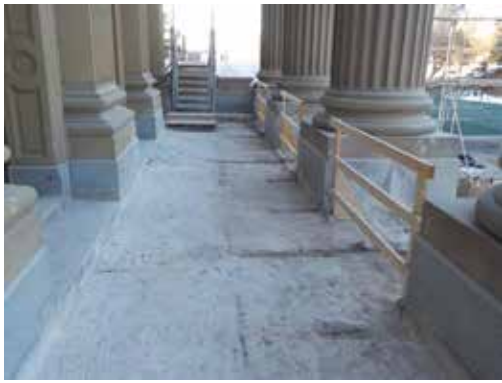
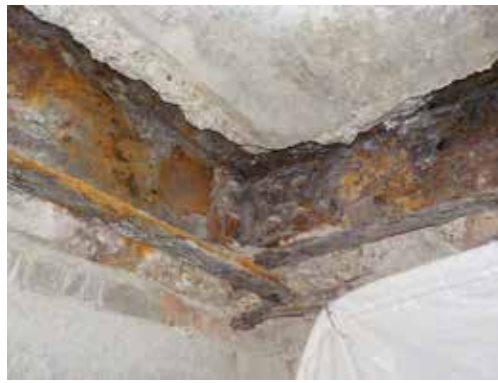
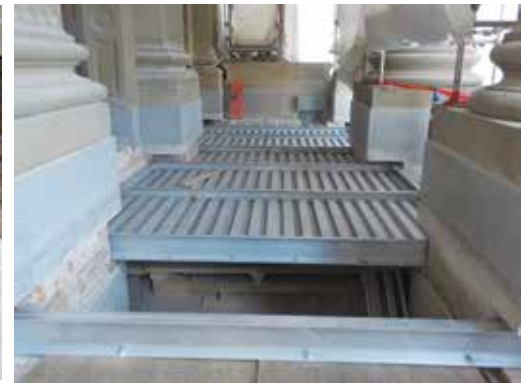
*From left to right: Severely corroded existing steel framing beneath the colonnade deck. Replacement colonnade steel structure.*

During the work of the project, it was discovered that the steel structure supporting the colonnade concrete deck was severely corroded and required replacement. A new steel framing system and concrete deck slab was constructed.

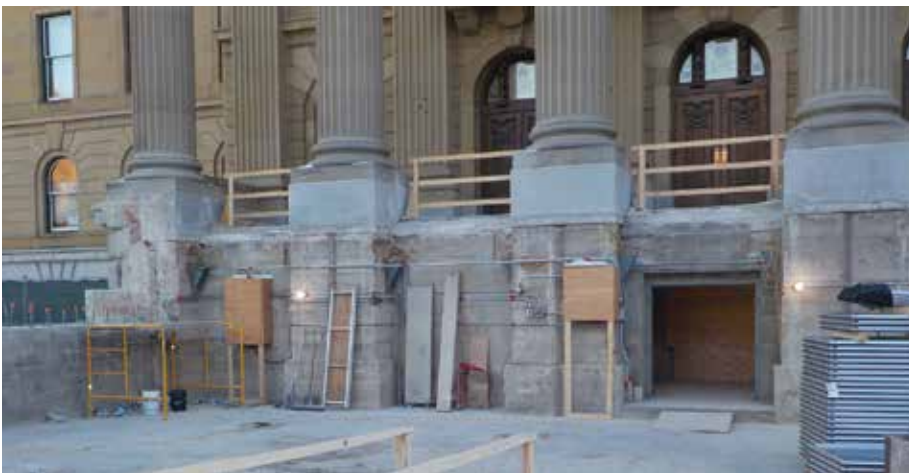
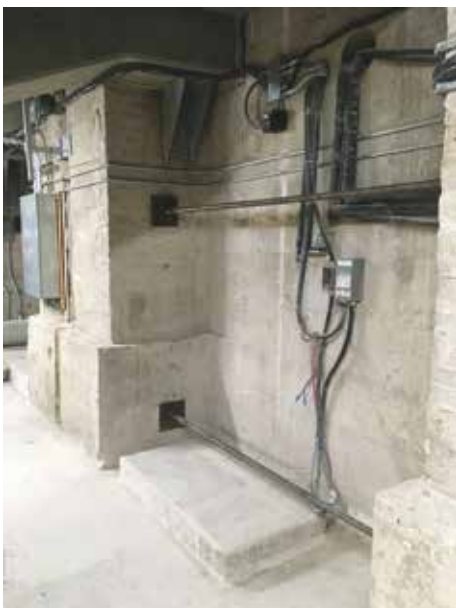
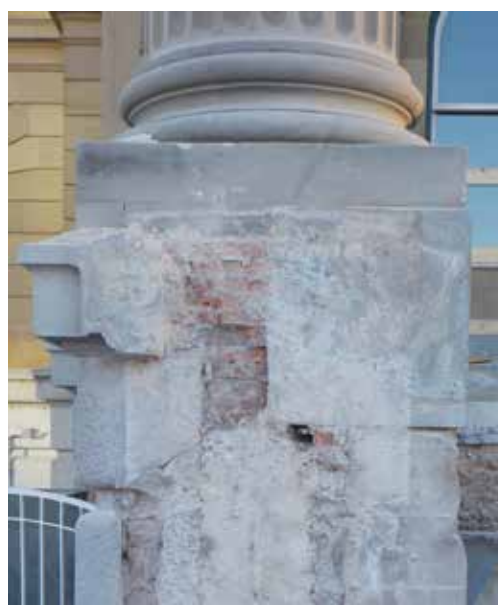
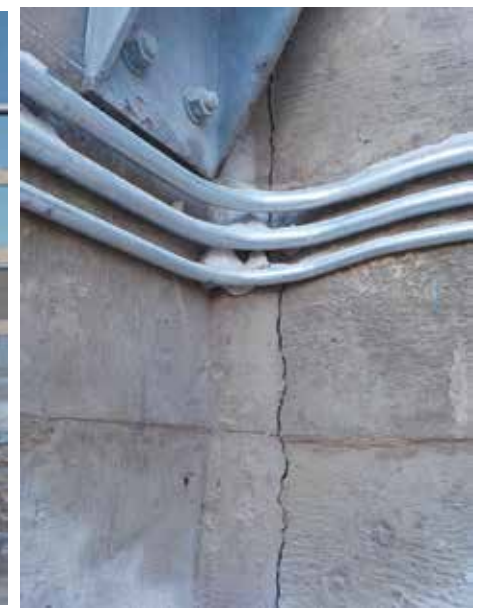
*Clockwise from left: Eastern freestanding columns and concrete pilasters. Cracking between concrete north corridor wall and east concrete pilaster. Diagonal cracking with masonry portion of east freestanding column pilaster. Pilaster tie system.*

As a result of the cracking and apparent lack of suitable tie-in of the north corridor wall to the column pilasters, a tie system was designed and installed using two rows of 1¼ inch (32 mm) diameter tension rods to connect the outer pilasters to the

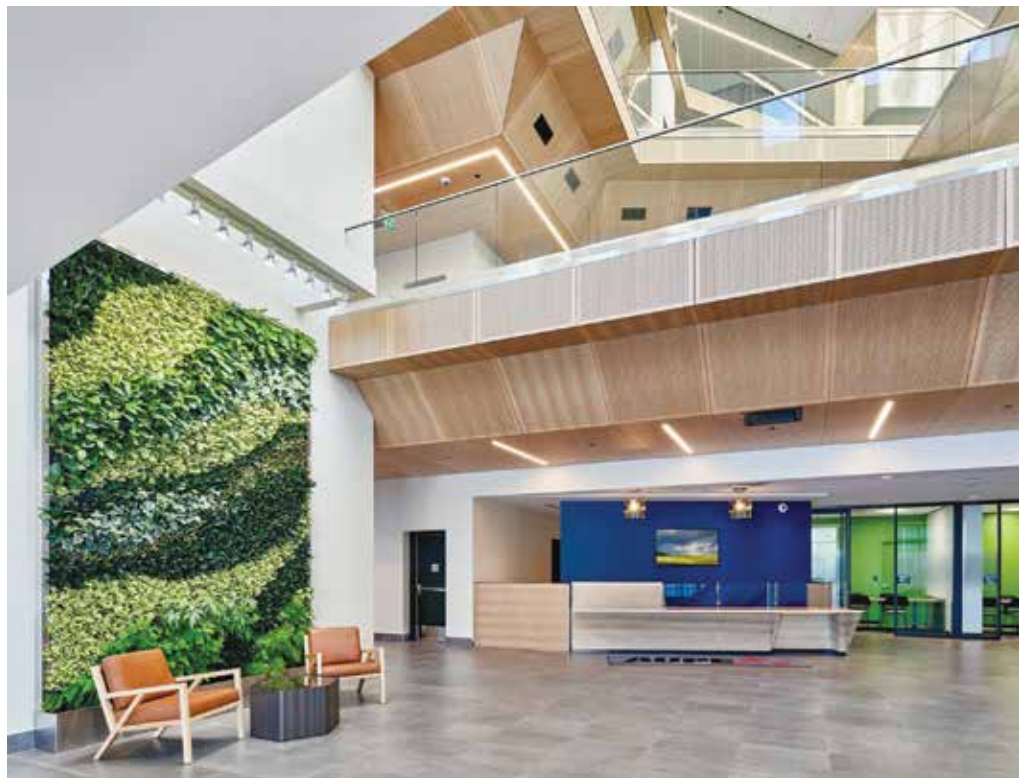
*Living wall featuring over 1,000 plants. Image credit: Next Architecture.*

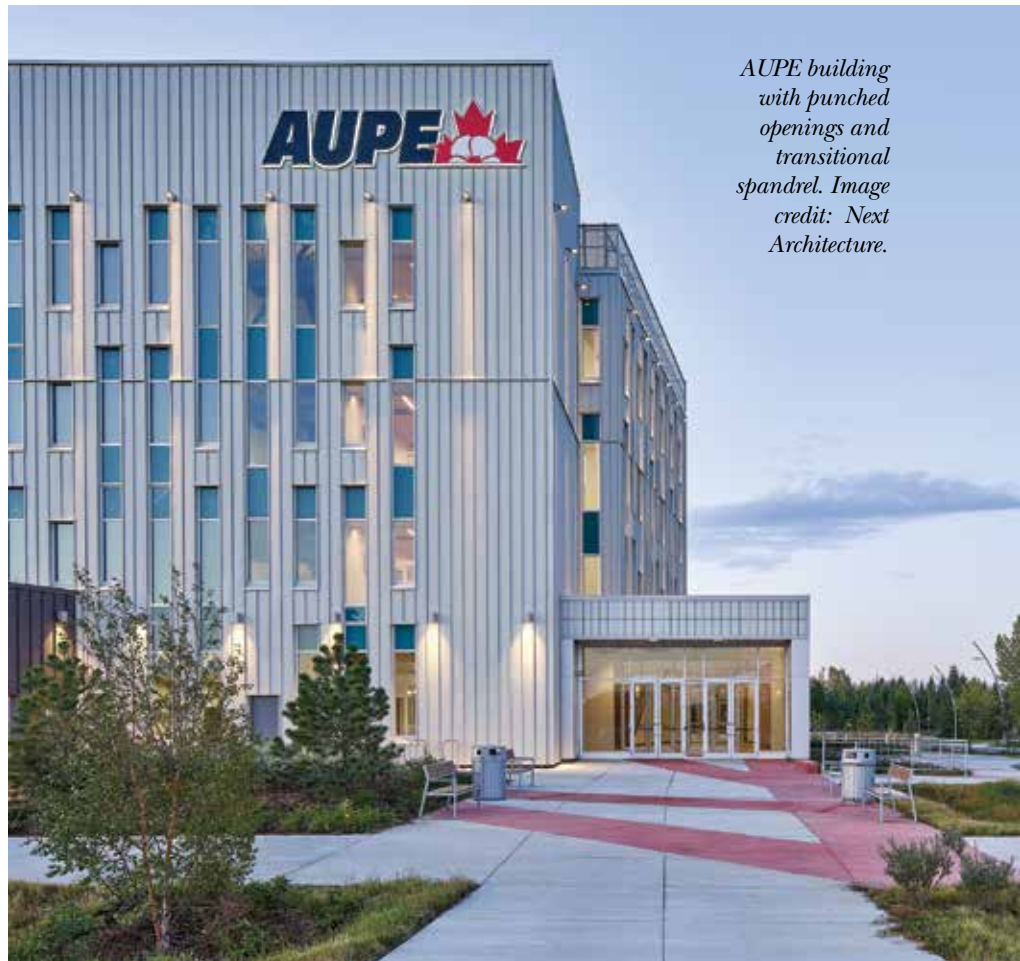
*FiberWall™ Series 658 Fixed Windows with Cardinal LoE-272 Insulating Glass, Sill Perimeter, and custom transitional spandrel supplied by DUXTON Windows & Doors.*

*AUPE building with punched openings and transitional spandrel. Image credit: Next Architecture.*

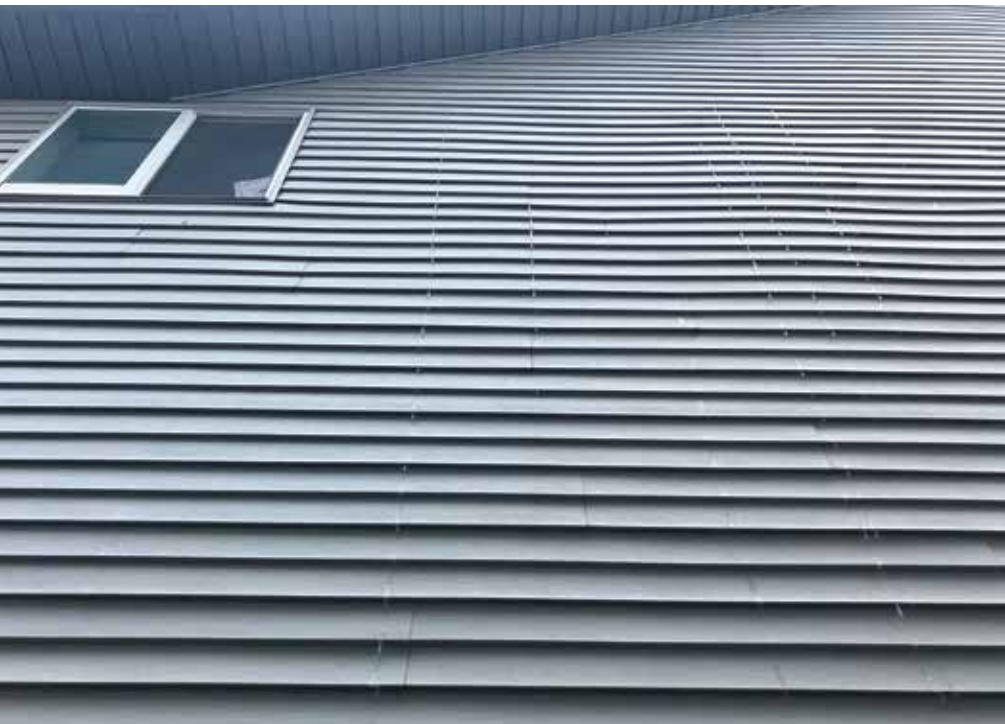
*Photo 1: Water dripping from behind the siding.*

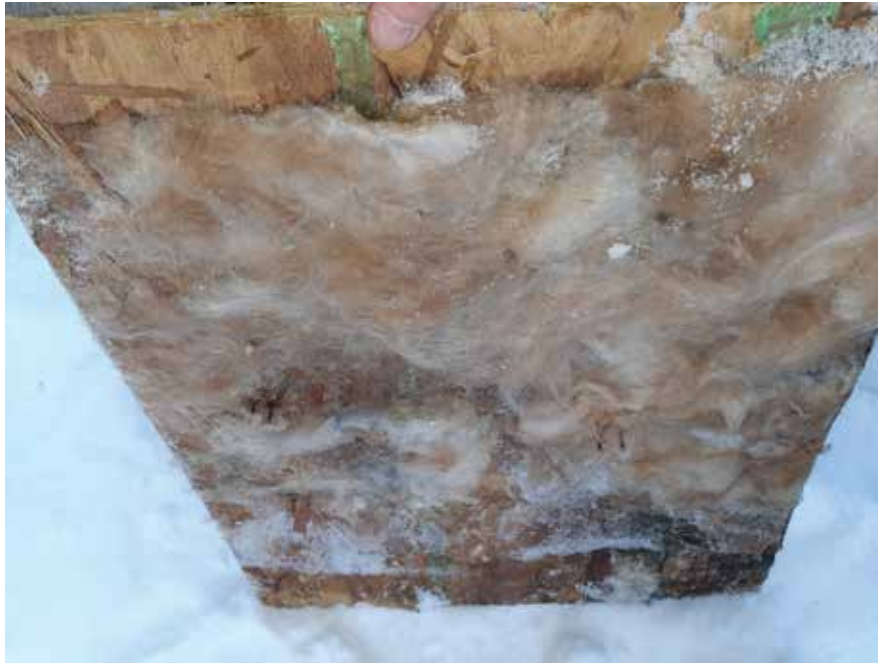
*Photo 2: Wet and frozen insulation and OSB sheathing.*

At the exploratory openings in the affected areas, the OSB sheathing had elevated moisture content. Due to the high moisture content, there was swelling and bowing in the OSB sheathing, and suspected mould growth in several locations (Photos 2 and 3). The waviness in the vinyl

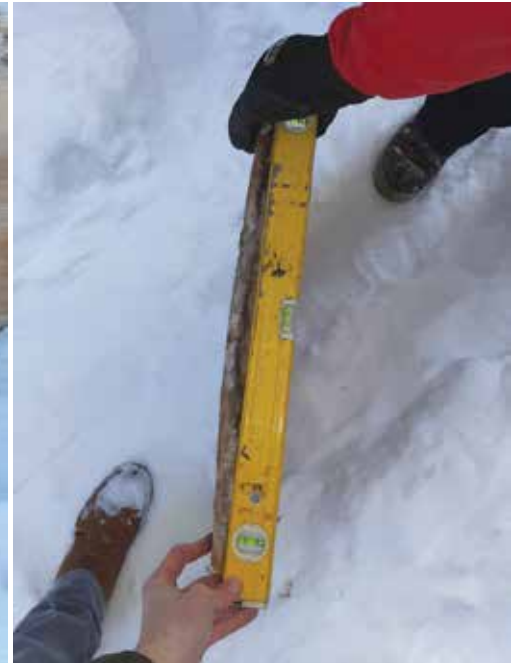
*Photo 3: Bowing in the OSB sheathing.*

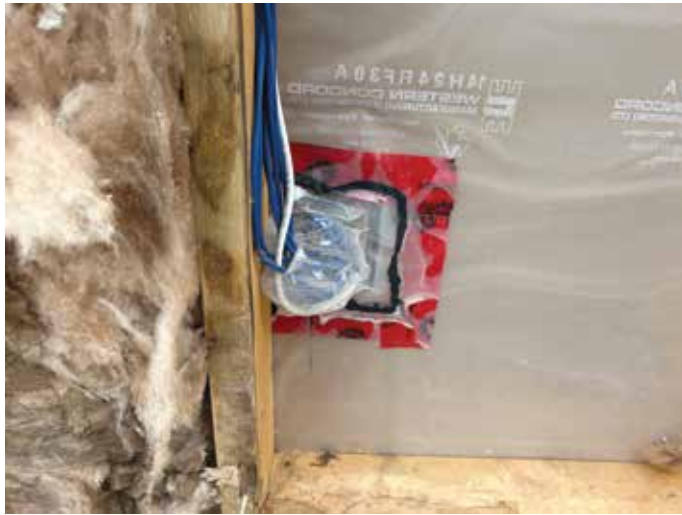
*Photo 4: Unsealed cable penetrations through the polyethylene sheet.*

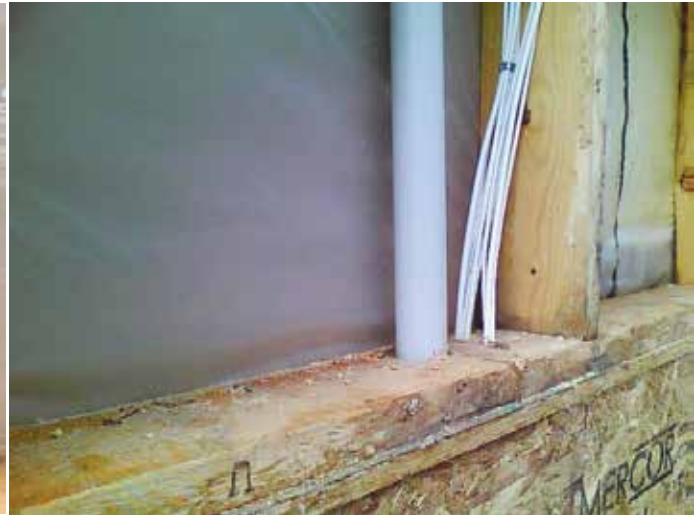
*Photo 5: Typical unsealed plumbing and electrical penetrations extending through the second-floor sill plate.*

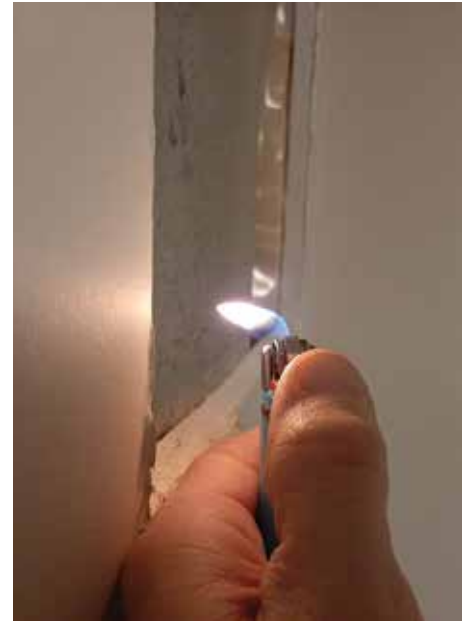
Photo 7: Crude but effective visual of depressurization of the exterior wall below the second-floor cavity.

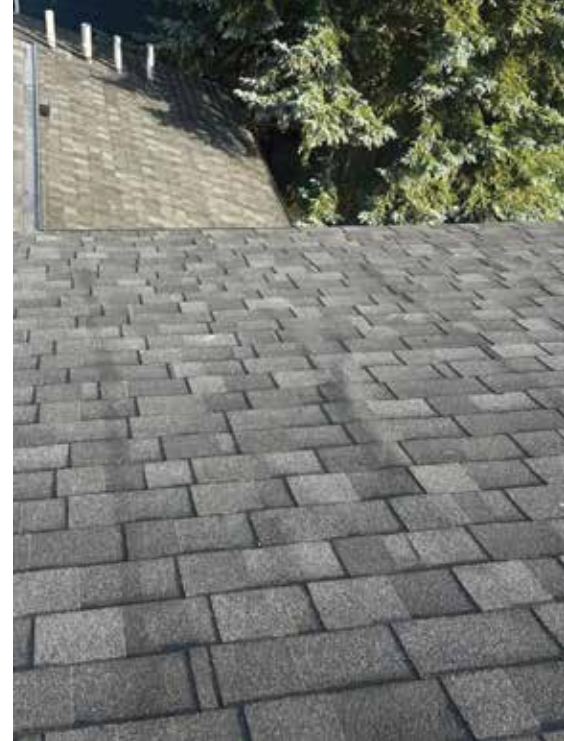
*Photo 1 - Steep slope roof, ridging clearly visible in shingles following the rafters.*

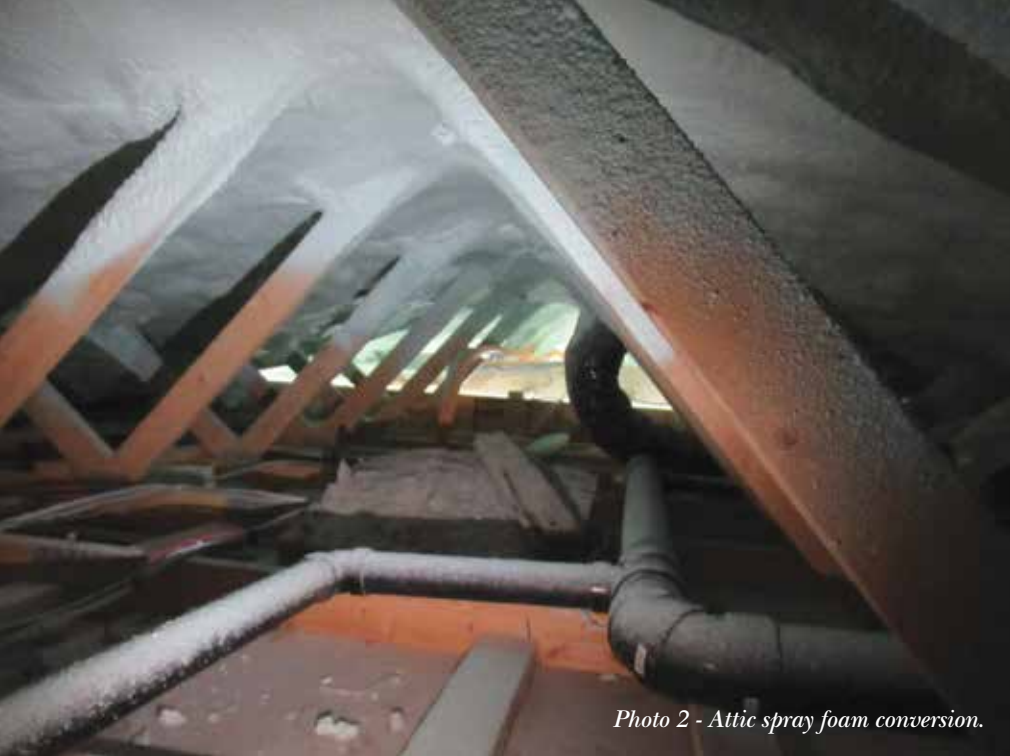
*Photo 2 - Attic spray foam conversion.*

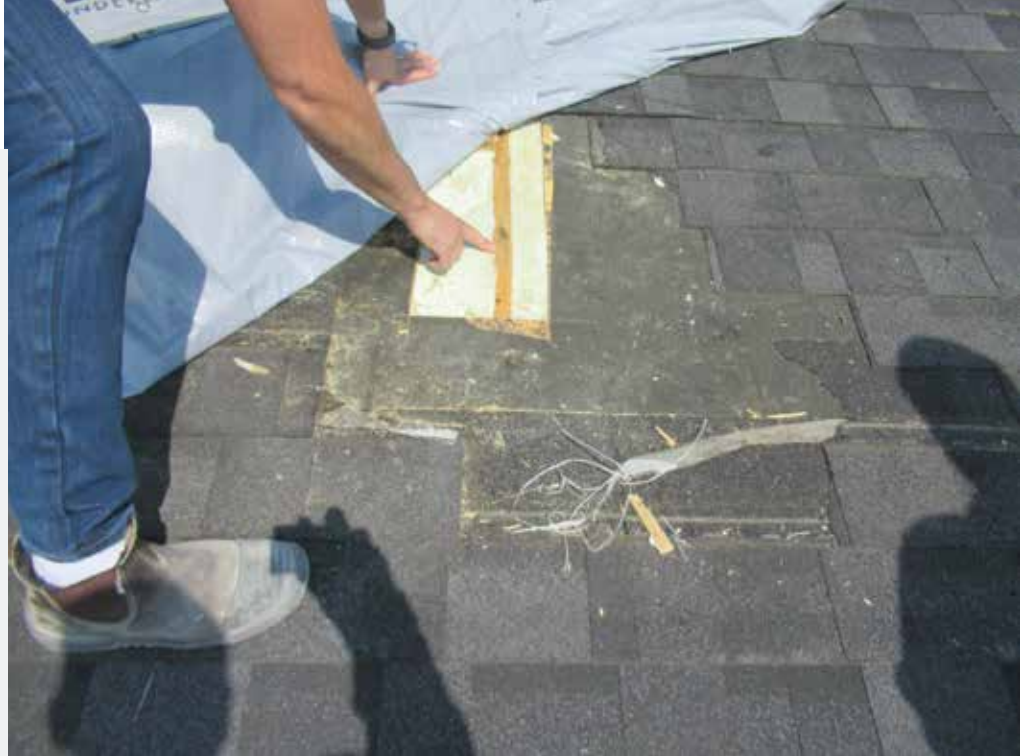
*Photo 3 - Roof investigation at one of the shingle ridging locations. Sheathing removed to expose spray foam.*

Even small increases in roof temperature can have a substantial impact on vapour pressures. It is clear that vapour pressure spikes below the adhered underlay caused the blistering and visible ridges.

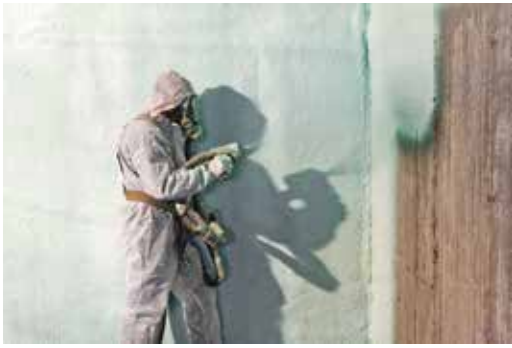
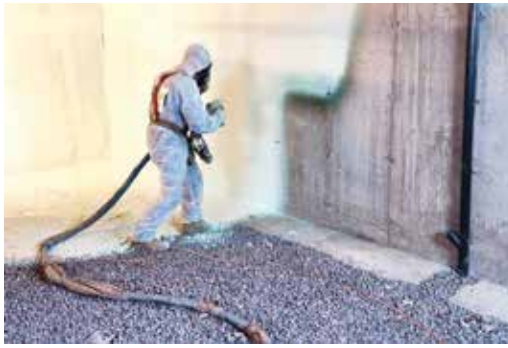
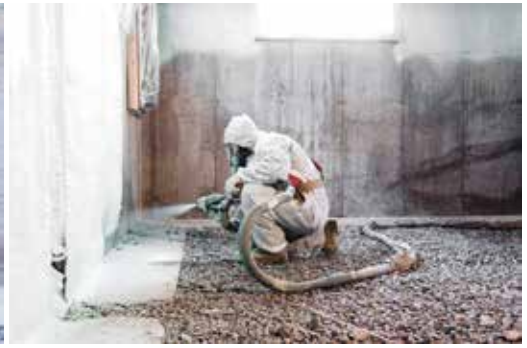
*Contractor spraying a polyurethane spray foam insulation product. Photo courtesy Huntsman Building Solutions (HBS).*

The development and adoption of technologies are significantly transforming the air barrier systems industry. For example, spray foam, which combines insulation and air barrier functions, has been tested and approved in several assemblies for decades as an air barrier system. It has been frequently used in large buildings due to its excellent air sealing properties and thermal performance and is now being used in buildings that need to meet the

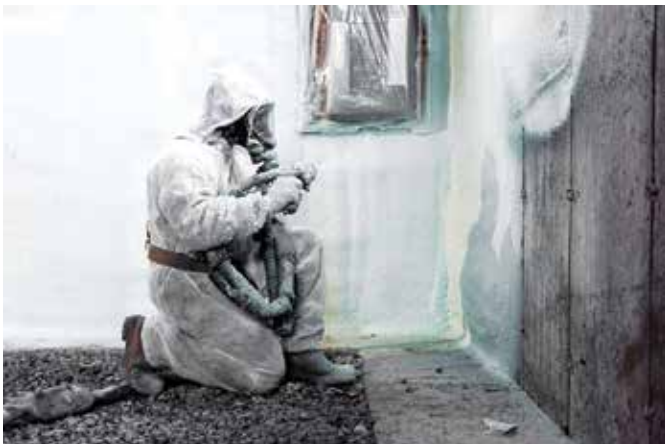
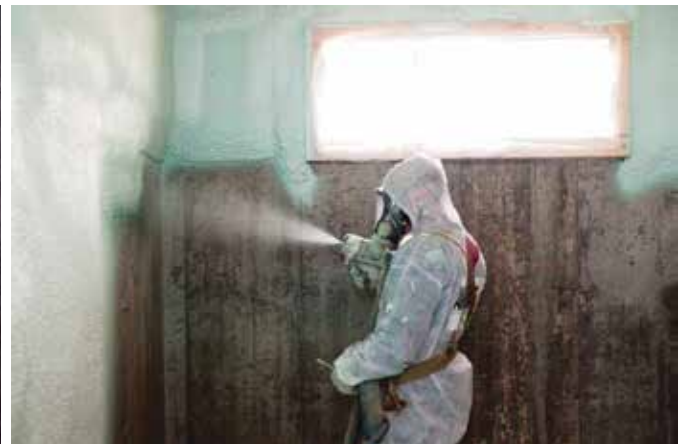
*Spray polyurethane foam (SPF) plays a significant role in mitigating common air leakage paths, such as joints, seams, and penetrations, thereby enhancing the airtightness of buildings.*

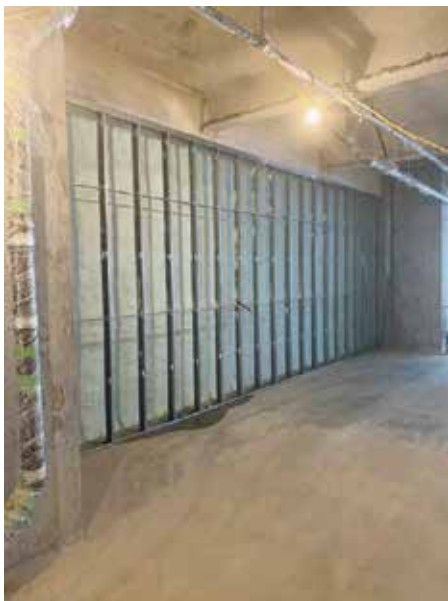
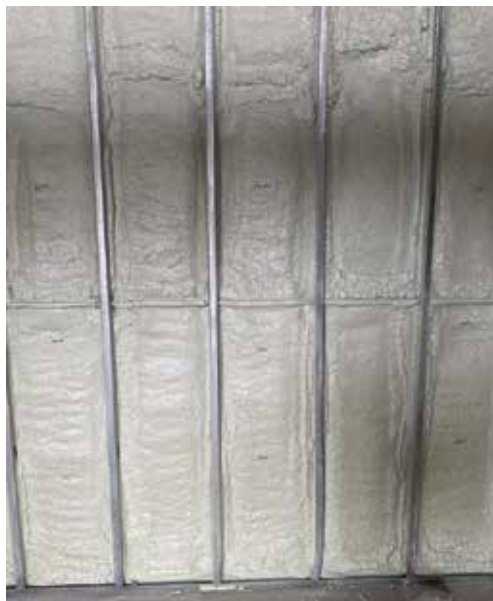
*Far left: Application of hydrofluoroolefin (HFO) to achieve high RSI-values.*

*Spray polyurethane foam (SPF) can be applied using various methods, including spray guns and portable units. The choice of application method depends on the project size, complexity, and specific requirements.*

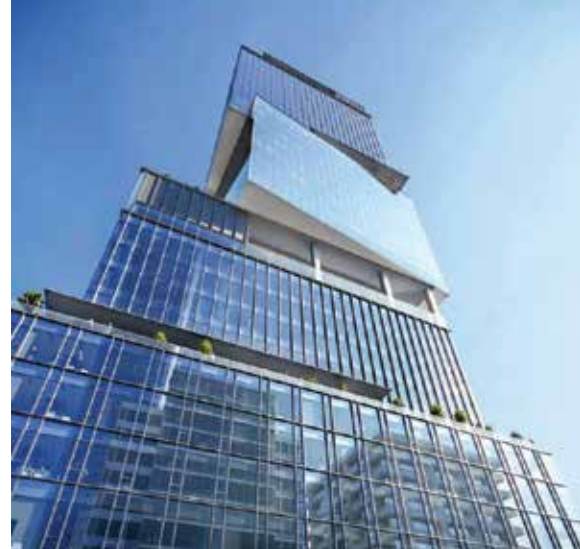
*The Stack, a modern office building in Vancouver, B.C., is an example of using spray polyurethane foam (SPF) insulation as the air barrier system to enhance energy efficiency and durability. Photo courtesy of The Stack.*

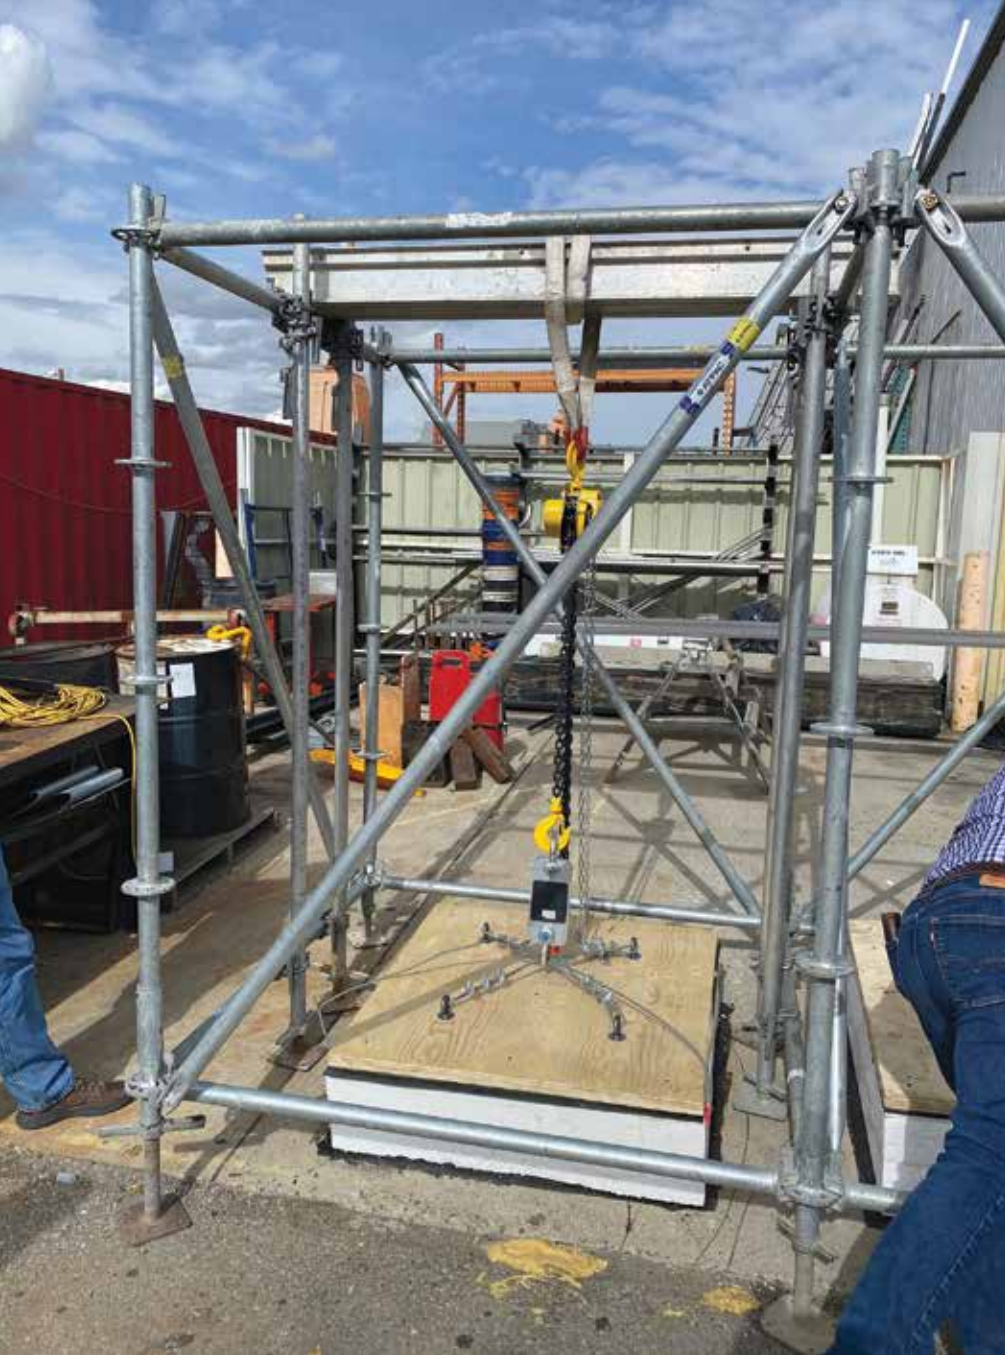
*Photo 1 - Test setup at contractor's yard.*

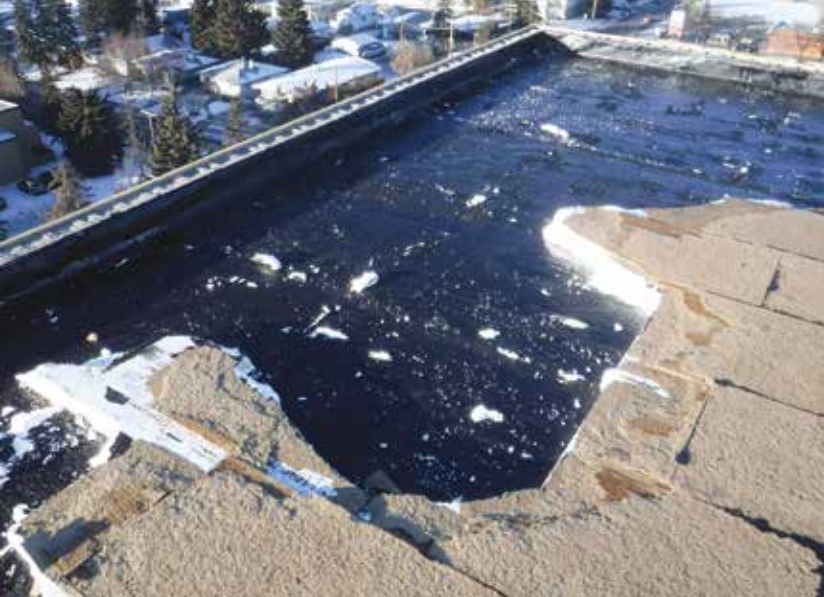
*Photo 2 - Roof blown off at northwest corner of building.*

We were asked to investigate a roof failure in southwest Calgary after a significant wind event. The winds were generally from the northwest and were noted to be approximately 60 to 90 kph. The roof peeled off the building as shown in Photos 2 and 3. The roof was described as a 'mop and flop' where layers are adhered using

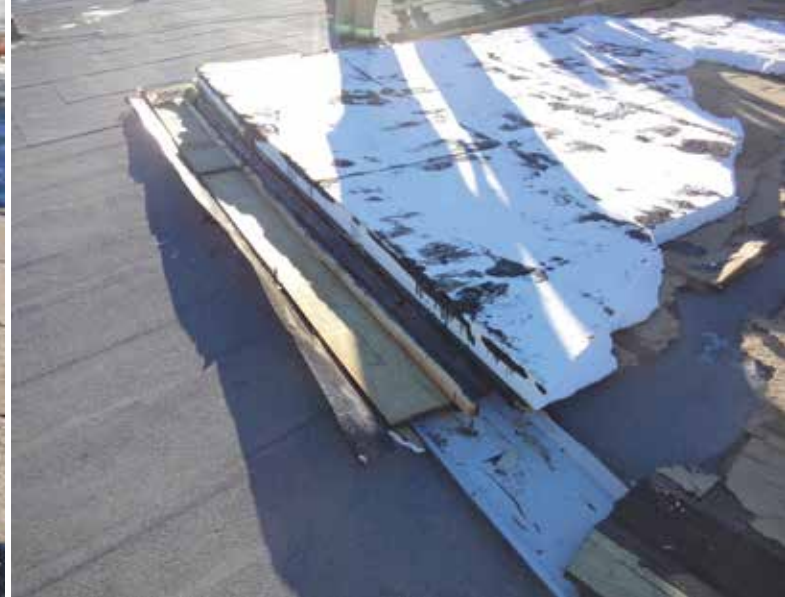
*Photo 3 - Underside of roof assembly showing parapet components which had been nailed to the CMU parapet.*

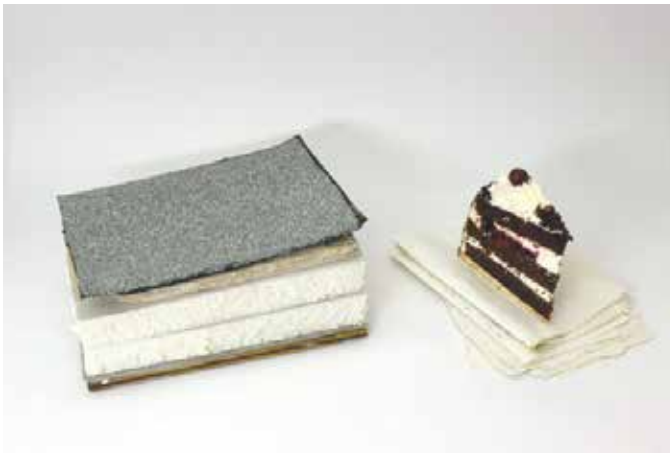
*Imagine your roofing system as a multi-layered cake can be a helpful way to understand its components.*

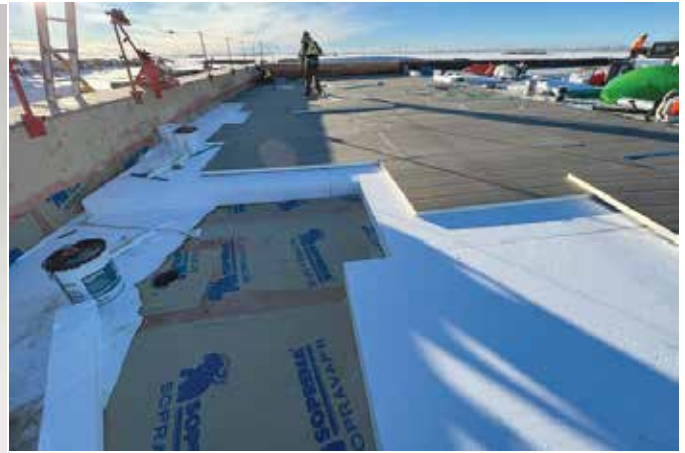
*With proper installation and regular maintenance, flat commercial roofs tend to have a typical life expectancy of approximately 20 to 25 years in the Canadian climate.*
